## **A Proposed Highly Damped Repair for the Aft Fuselage of the F/A-18**

DSTO-TR-1374

**Air Vehicles Division**  
Platforms Sciences Laboratory

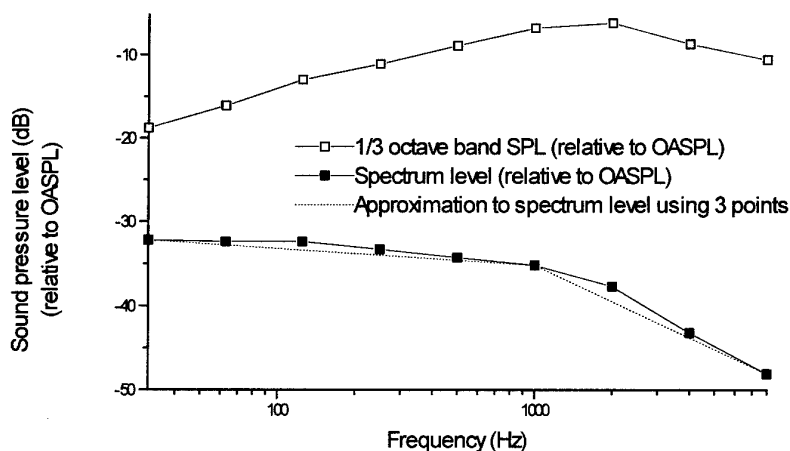
Figure 2. Spectrum and one-third octave band levels of sound pressure over the external nacelle inlet, (where OASPL=170 db), [1]

Since the cracking on the inlet nacelle preceded that in the aft fuselage then it is conservative to assume the same power spectral density (PSD), as measured at the nacelle as shown in Fig. 2. The overall sound pressure (OASPL) measured at the nacelle was 172db, which is considerably greater than the design value of 160 dB for the airframe, [1]. Premature cracking in the aft fuselage suggests that an additional aerodynamic disturbance is responsible for the higher than expected sound pressure level (SPL). The possibility exists that the flap may be responsible for this. Fig. 3a and 3b show the flap deflection for landing and in-flight conditions. Note that the in-flight position corresponds to the location of the metallic repair. In the case of the B52, [9], it was found that cracking in the aft fuselage skin was a result of the aerodynamic disturbance caused by the deflected flap position during take-off. However aerodynamic disturbances can also be caused by high angle of attack manoeuvres resulting in separation of airflow over the flap.

The spectrum curve in Fig. 2 has been approximated with the three points listed in Table 1.

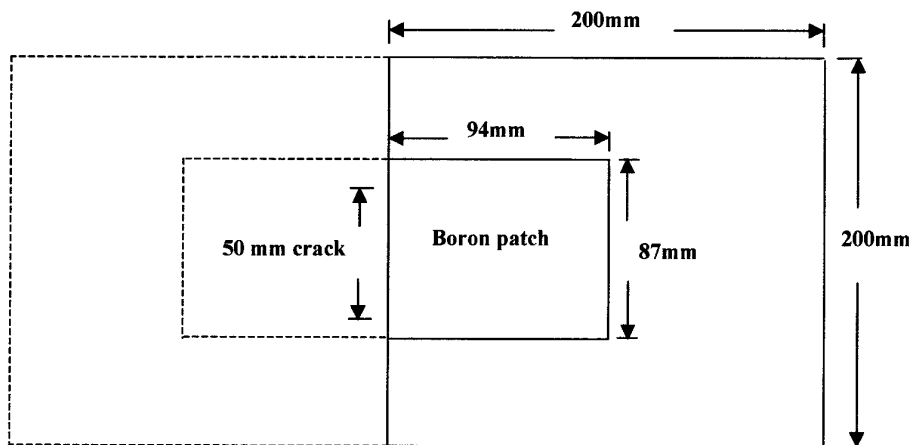
Figure 4. Dimensions of repair, plan view

In order to study the cracking mechanisms of the cracked and repaired/cracked aft skin cases, a simplified model has been developed in which the skin is considered to be a flat rectangle. Most of the skin panels in which cracking occurs have a chemical milled step in which the panel is reduced in thickness to 0.91mm. While the width and height dimensions of each panel vary, the F.E. model has representative dimensions as shown in Fig. 4. Also shown in Fig. 4 the local uni-directional patch extends partially across the panel, but since the crack lies near the boundary the repair will continue across the adjacent panel as shown in the dotted outline. In order to accurately represent the bending of the panel, 2 layers 20 noded brick elements have been used through the thickness. The F.E. mesh is shown in Fig. 5. The local boron/epoxy repair [O<sub>3</sub>] has been applied to make up for material lost as a result of the crack. The highly damped section of the repair covers the entire panel including the local boron patch. This section consists of two viscoelastic layers with two boron/epoxy [0/90] constraining layers as shown in Fig. 6. The viscoelastic layers and adhesive have been modelled using 3D elements as are the constraining layers. The total structure consists of 7000, 20 noded brick, elements and 29000 nodes.

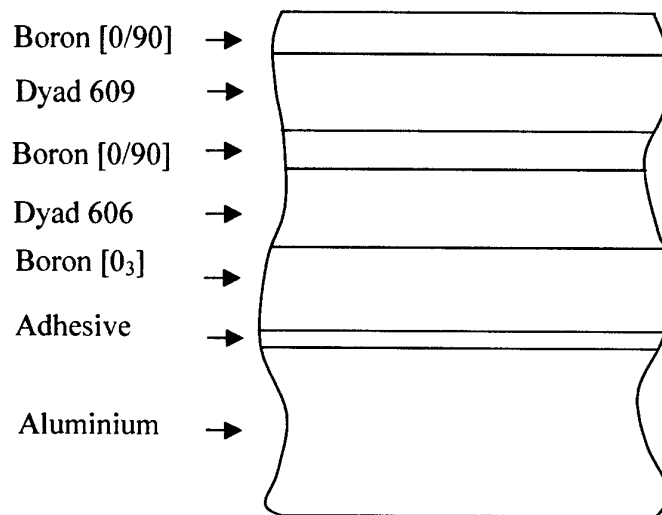
Figure 6. Components of the highly damped repair

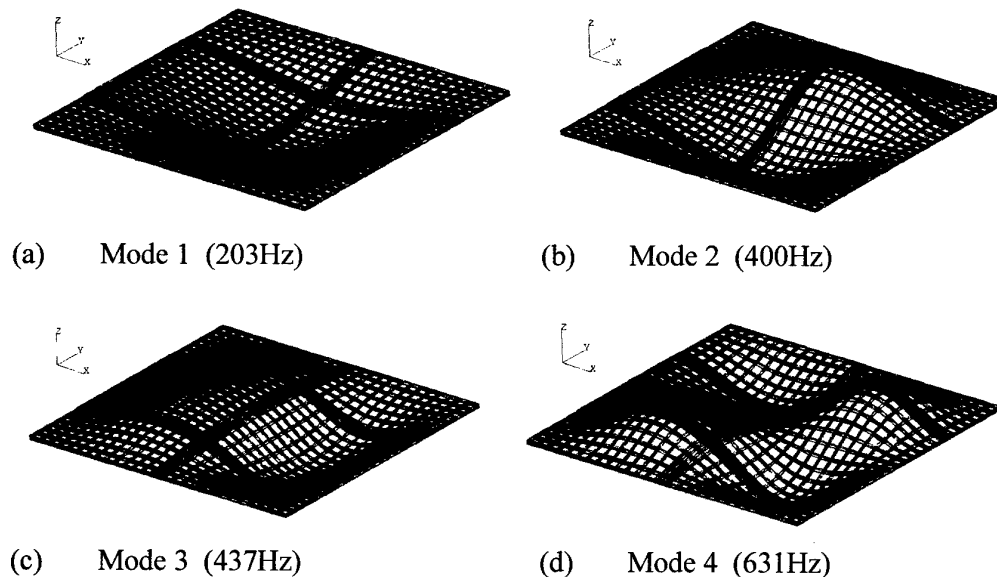
Figure 7. Modes and frequencies for repaired plate

A modal analysis has been carried out using NASTRAN program, [11], to determine the mode shapes and frequencies. The first four mode shapes are shown below in Fig. 7. The PSD of the response is plotted in Fig. 8 From this curve it is clear that mode 1 provides the greatest contribution to the response at a frequency of 203Hz. The mean square contribution of the other modes is more than one order of magnitude smaller than that for mode 1.

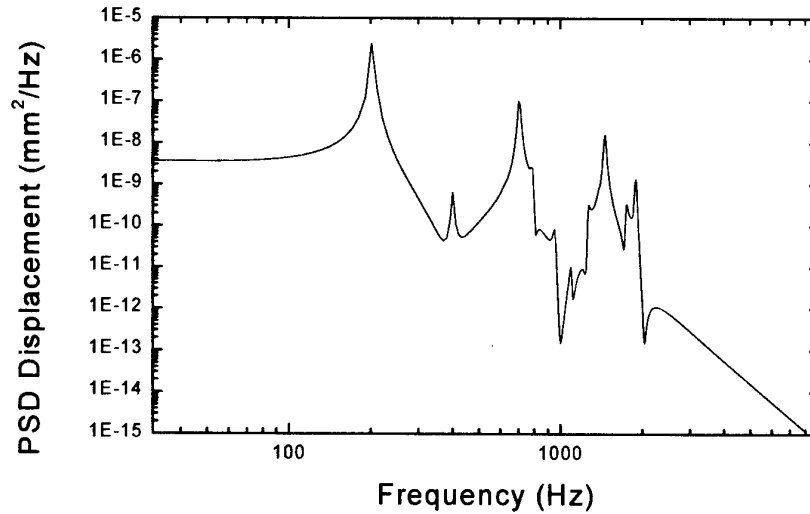
Figure 8. PSD of the response (i.e. mean square of the displacement near the crack tip)

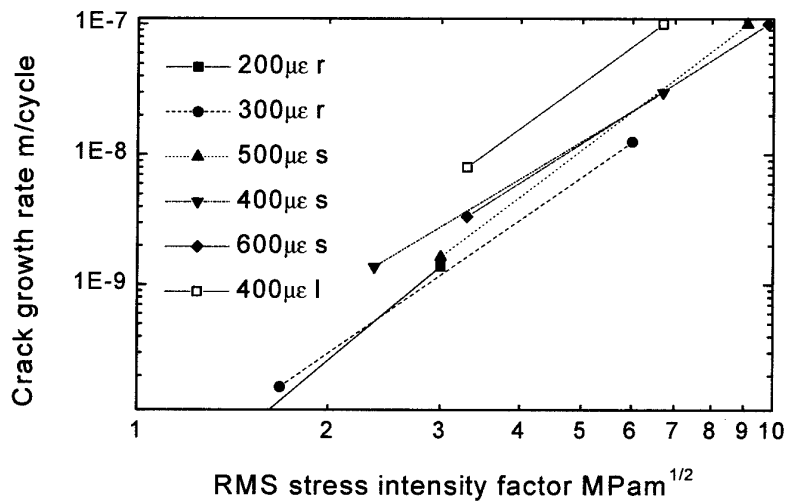
Figure 9. Acoustic fatigue crack growth data for clad 2014-T6, ( $\mu\epsilon$  denotes microstrain, r denotes random, s denotes sinusoidal and l denotes low reversal rate).

In this study it has been necessary to show that standard crack growth laws can be applied to structures subject to high frequency out-of-plane bending excitation. While acoustic fatigue data is very limited a comparison has been made with L73 data (U.K. spec.) and a standard crack growth law. The L73 (clad) alloys, [13], shown in Fig. 9, is equivalent to 2014-T6. The crack growth law for 2014-T6 is given by [14] as:

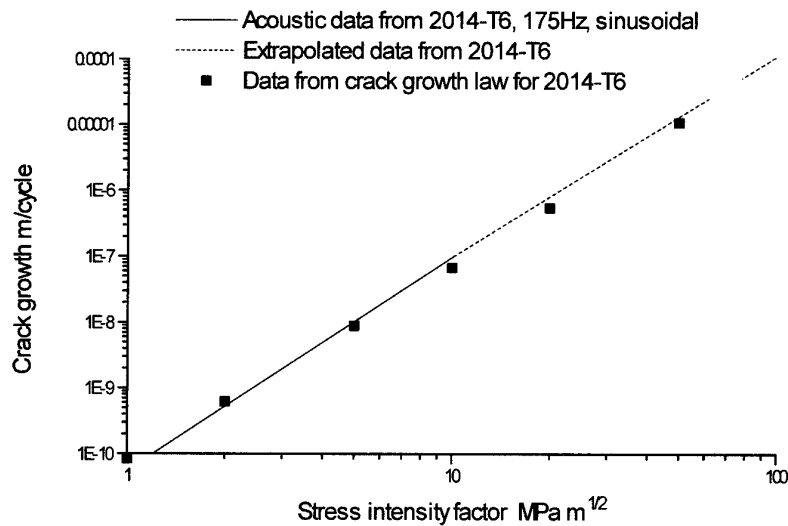
Figure 10. Crack growth data and crack growth law

The crack growth law is usually determined from testing at a frequency of typically 4-10 Hz. Also equ(6) is only valid for a range of 6-50 MPa  $m^{1/2}$ . A comparison between the crack growth law prediction and the 2014-T6 data is shown in Fig. 10. The experimental data corresponds to a sinusoidal data at 175Hz and shows surprisingly good agreement. The random data has not been used since the slopes of the curves show significant disagreement, with similar strain levels.

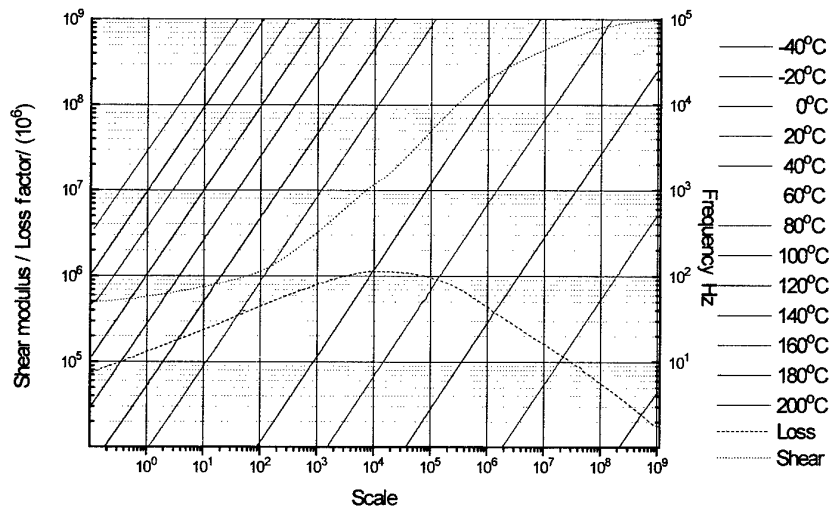
Figure 11. Dyad 606 material data. (To obtain loss factor divide shear modulus scale by  $10^6$  )

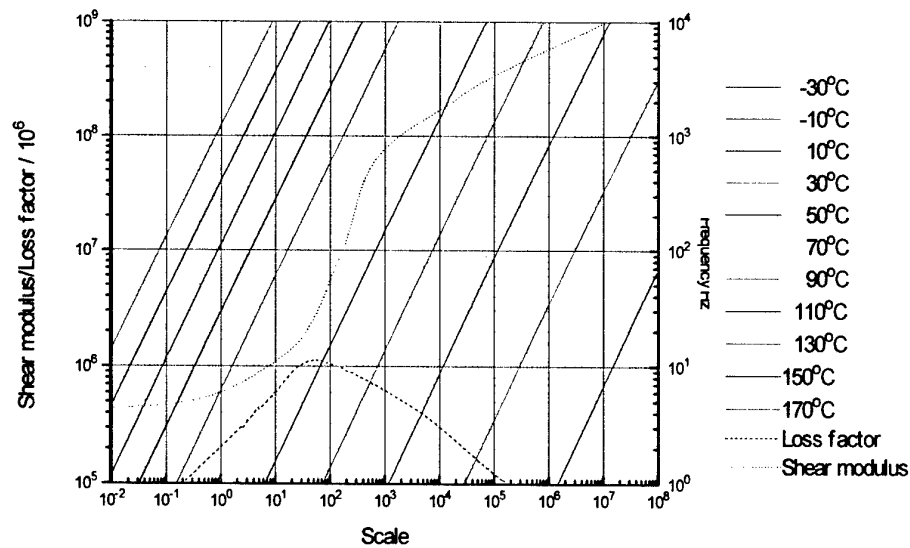
Figure 12. Dyad 609 material data.(To obtain loss factor divide shear modulus scale by  $10^6$  )

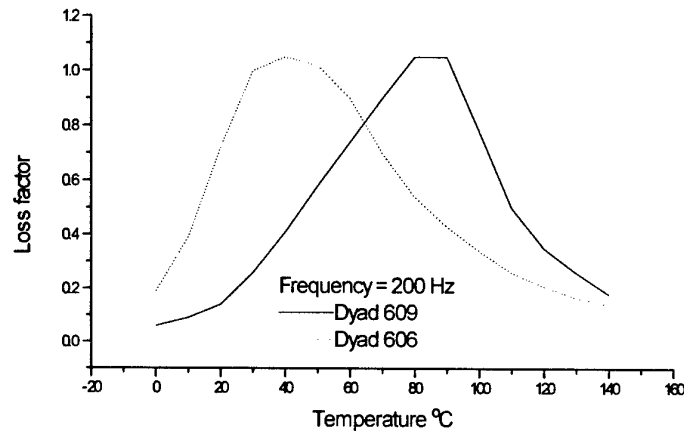
Figure 13. Comparison of Dyad 606 and 609 over the entire temperature range.

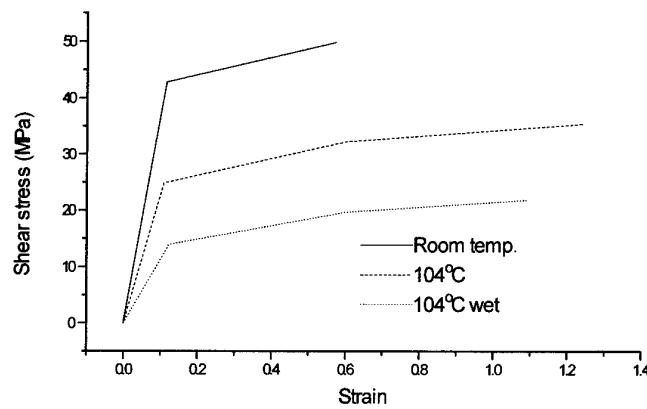
Figure 14. Stress strain diagram for FM300K for a temperature range shown. (plot1,FM300K, demonstrator)

Stress strain data is available for FM300, [17], and is shown in Fig. 14 as a function of temperature. The service temperature for this adhesive is from  $-55^{\circ}\text{C}$  to  $150^{\circ}\text{C}$ . Only two data points exist for each temperature case, as a result values for shear modulus have been extrapolated. Using dry data the shear modulus is given by:  $G = 1281 - 7.419T$  (MPa).

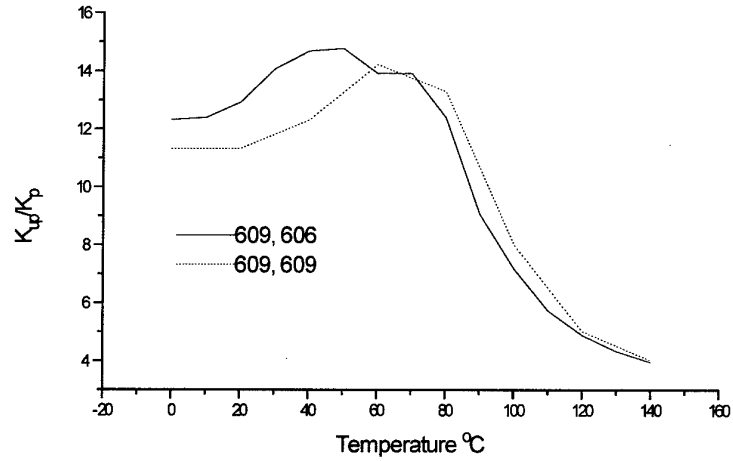
Figure 15. Plot of  $K_u/K_p$  versus temperature for configurations using 609 and 606.

In Fig. 15 a plot is shown of the variation in the ratio of stress intensity factor, for the cracked unpatched plate ( $K_{up}$ ) to the stress intensity of the repaired plate ( $K_p$ ), with increasing operating temperature for a patch incorporating both 606 and 609 (viscoelastic material) VEM and two layers of Dyad 609 VEM. The stress intensity factor (SIF) was calculated using the F.E. model described in section 5 and the analysis includes the thermal residual stress contribution and softening effect of the adhesive. A significant reduction of  $K$  is shown over the complete temperature range. Results using two layers of 609 are also shown in Fig. 15.

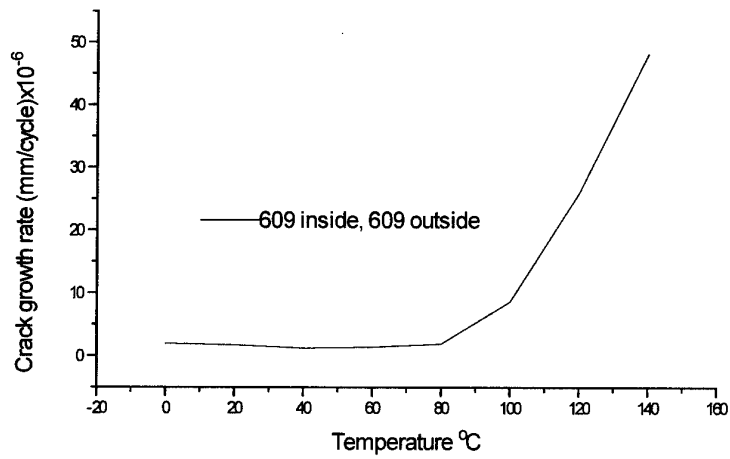
Figure 16 Crack growth rate for highly damped repair.

Fig. 16 shows the crack growth rate for 7075-T6 cracked plate incorporating a patch with two layers of Dyad 609 over the temperature range of interest. In this figure, equ(6) is used to obtain the crack growth rates, with relevant coefficients, including both thermal residual stresses estimated from a closed form solution and adhesive softening. The crack growth rate is relatively low for temperatures of 80°C, beyond this the crack growth increases significantly. In comparison Fig. 17 shows that the crack growth rate for the cracked unrepaired panel compared to the repaired panel is approximately 2700 time greater for temperatures around 40°C. Even at 140°C the crack growth rate of the cracked unrepaired panel is 70 times then that for the repaired panel.

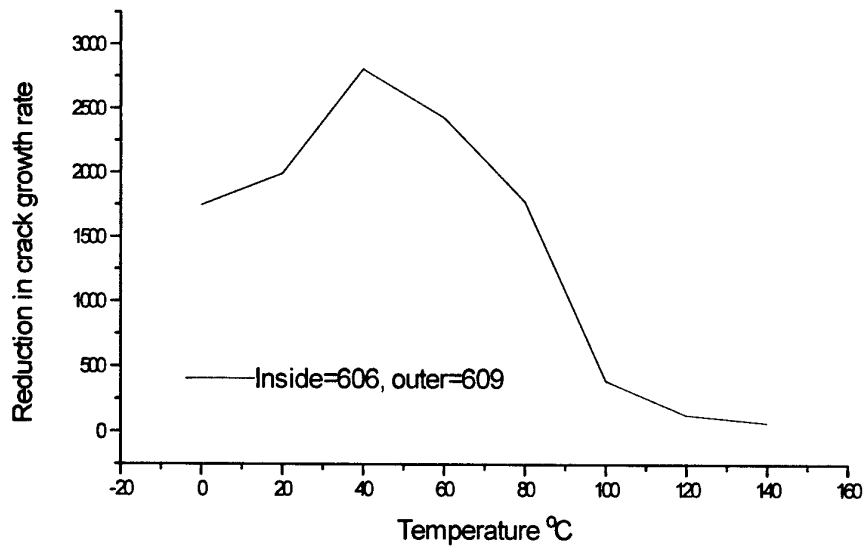
Figure 17. Reduction in crack growth rate for highly damped repair compared to cracked unrepaired plate.

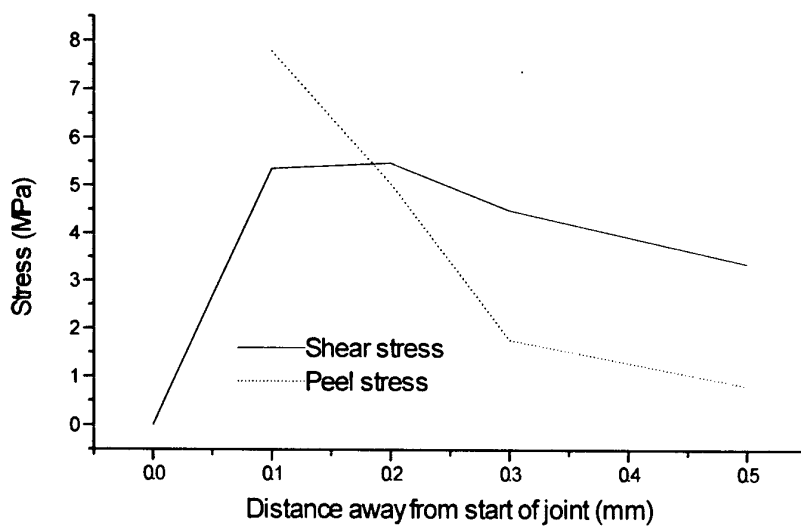
Figure 18. Adhesive stresses bonding boron to aluminium at room temperature.

The adhesive shear and peel stresses in the adhesive layer of the boron repair the are shown in Fig. 18 for the room temperature case. At this particular SPL the stresses are relatively low and no yielding will occur under peel or shear.

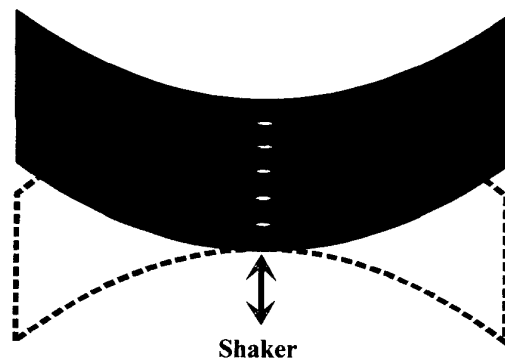
Figure 19. Flexing motion for butterfly specimen provided by a shaker.

Limited experimental work has been carried out in [19,20,21] in support of the analytical work. While differences exist between the aft fuselage geometry and specimens, similar experimental trends are expected. This work covers testing butterfly specimens which involve the flexing or bending motion shown in Fig. 19, provided by a shaker, in order to simulate the acoustic excitation. The geometry of the specimen is shown in Fig. 20. These specimens consist of bare aluminium specimens with boron/epoxy patches and Dyad 609 and 606 damping layers with  $[0,90]_s$  constraining layers. The highly damped repair was applied using room temperature curing adhesive Hysol EA9320. All panels were pre-cracked with a crack length of 25mm. In each case the maximum force applied to the specimen by the shaker was 90N. This forcing level achieved a nominal *rms* strain of about  $1000 \mu\epsilon$  ahead of the crack. Comparative results are shown in Fig. 21. In the case of bare aluminium specimens approximately 100,000 cycles were obtained before the resonant frequency of the specimen dropped by 15%. A 15% drop in resonant frequency was used as a criteria to indicate extensive crack growth. For boron/epoxy repairs approximately 1,000,000 cycles were obtained before the resonant frequency of the specimen dropped by 15%. In the case of the highly damped repair the first test with a shaker force of 90N gave no reduction in resonant frequency at 10,000,000 cycles, as shown by the dotted line. A second run was made with the shaker force increased to 180N. The results for this run are shown in Fig. 21. At approximately 10,000,000 cycles a 15% reduction of resonant frequency has occurred. The highly damped repair tested is slightly different to in that analysed above in section 5 in that the constraining layers of  $[0/90]_s$  are used in the experimental test rather than the  $[0/90]$  plies in the aft fuselage F.E. model. However the experimental results indicate that highly damped repairs are very effective in reducing the crack growth rate.

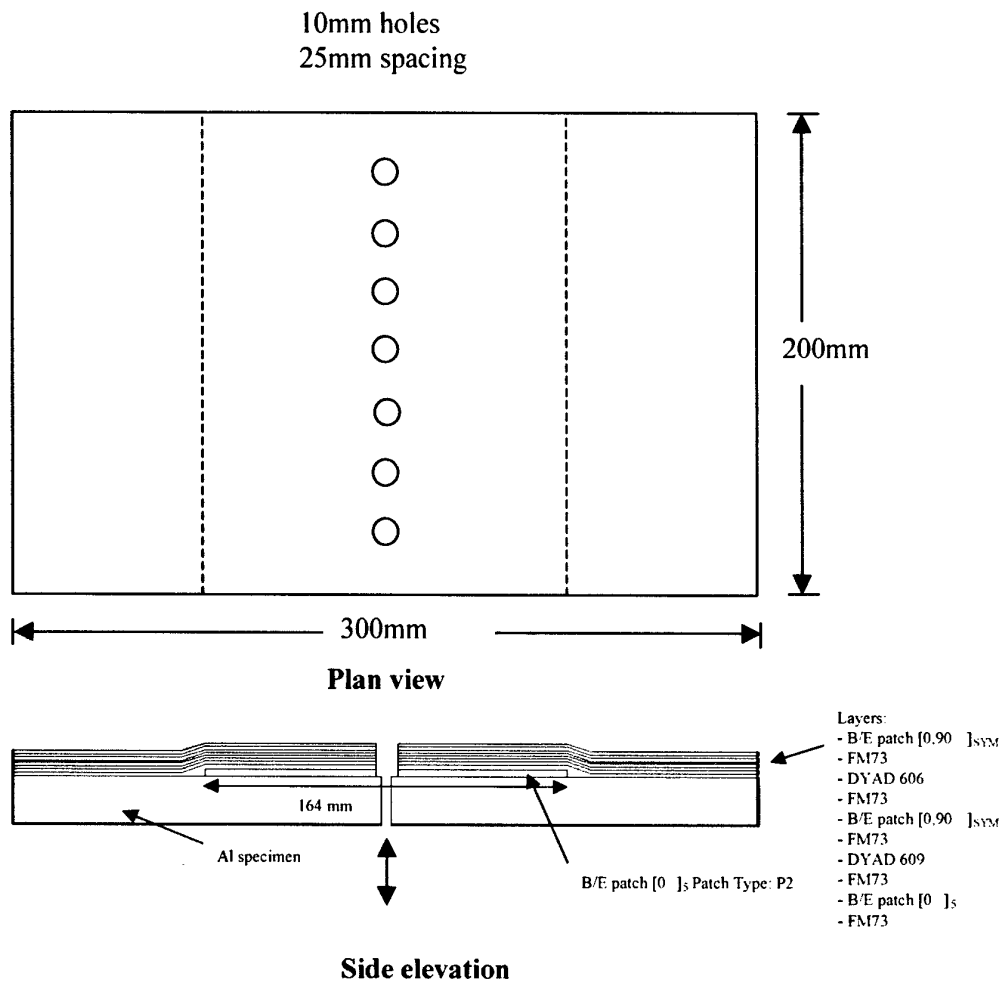
Figure 20. Highly damped repair configuration, from ref(19)

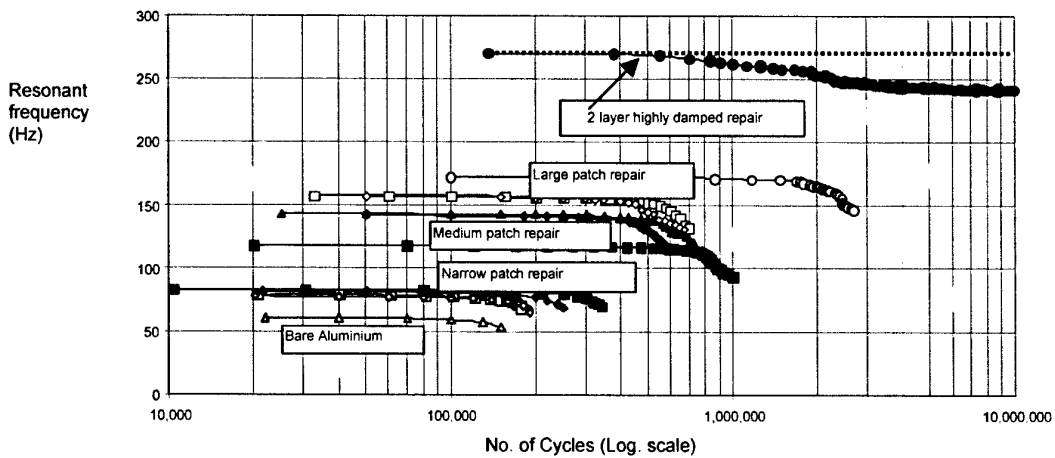
Figure 21. Comparative test lives for various specimens, from ref(22)
